JAMES CROSS, Certified Marine Surveyor

March 24, 2008

Re: 2002 Legacy 28 Express

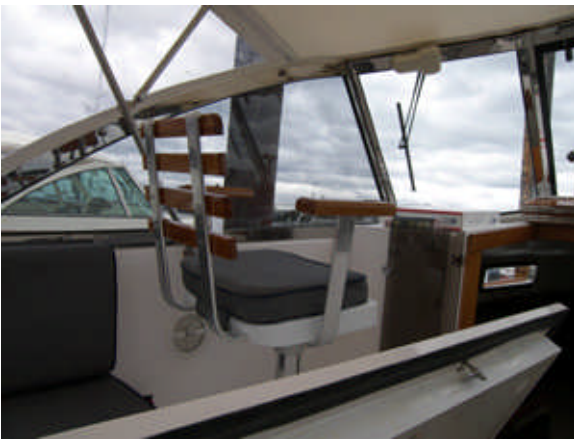
The operating station is well designed and the controls are easy to operate. The upholstery is in very good condition overall. The compass is accurate on its present heading. The shifts and steering are

also smooth operating and in good condition. Steering is hydraulic and the related lines are in good condition. The splash shield is in good, secure condition. All gelcoat surfaces at the operating station appear very lightly used. Overall, the station, including the upholstery is in good condition.

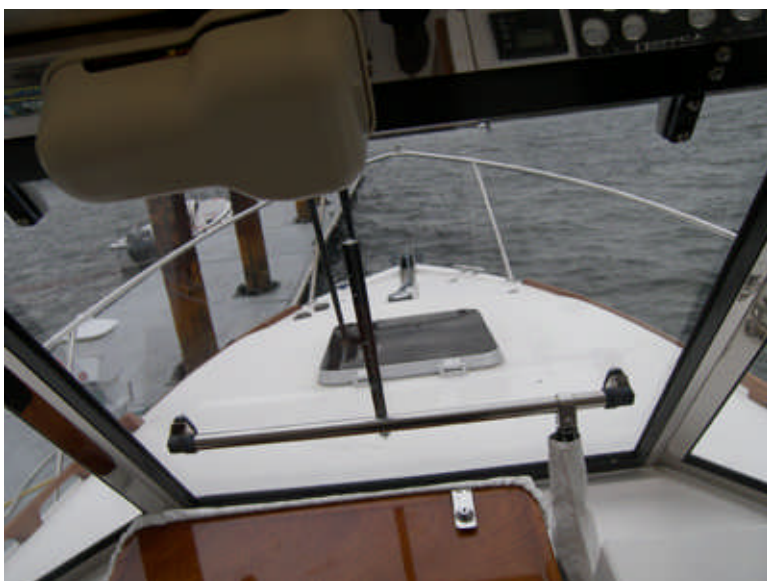
The cockpit is equipped with a variety of wells and storage locations, all of which are in good shape and functional. The aft deck is provided with scuppers, port and starboard, that

drain overboard at the stern. All cockpit drains and ports are in good condition. The cockpit coaming is teak trimmed. The teak trim is in good condition. Overall, the Cockpit, including the engine covers, deck, and trim is in good condition.

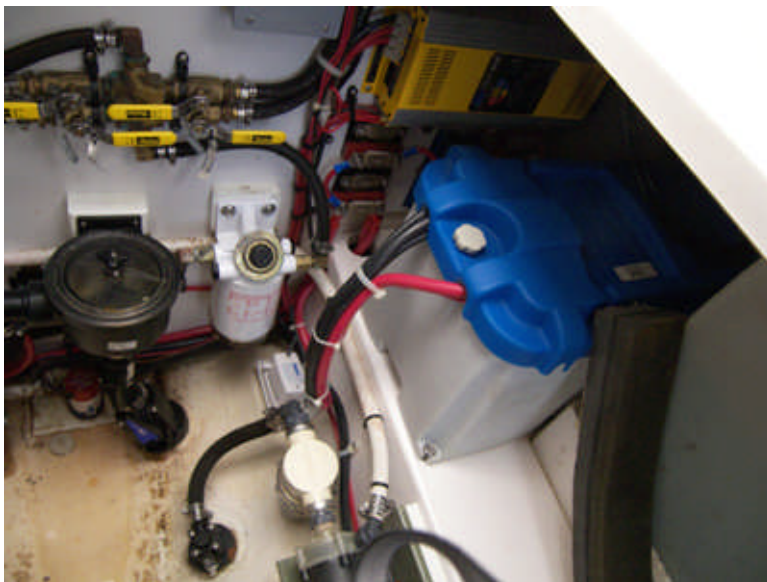
good condition.

Propulsion is by a Yanmar, fresh water cooled, Turbo charged diesel engine with reduction gear. The engine is rated at approximately three hundred horsepower. Visual inspection of the engine, oil, filters, and related connections show no signs of abuse. The fuel lines are in good shape. The stringers that support the engine mounts are heavily built and fiberglass covered and tabbed to the hull. The stringers also provide rigidity to the hull. The stringers are in good condition. The raw water intakes are equipped with a proper sea water strainer, and secure. The engines exhaust through an approved rubber composite hose through the transom. The exhaust system, as can be inspected, is in
