Re: 1987 43 Morgan Sloop

"OUR LOVE II"

This letter reports the results of a survey of the above vessel which was inspected while hauled and winterized on the 25th of June 2008 and then again on July 13th, of July 2008 while afloat, at Nortons Shipyard, in Warwick, Rhode Island. You requested the inspection to establish its condition and value. I have made only a visual inspections of the engine and gears.

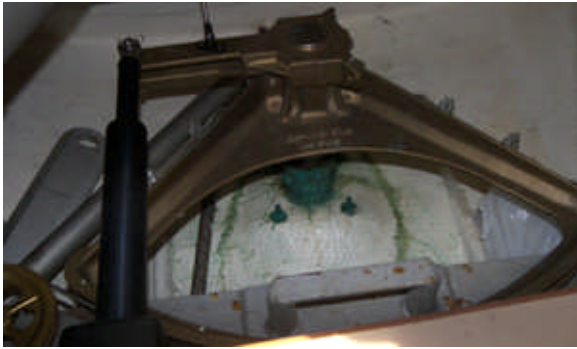
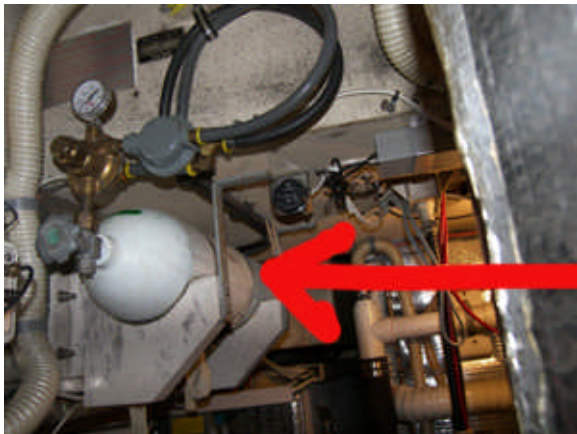
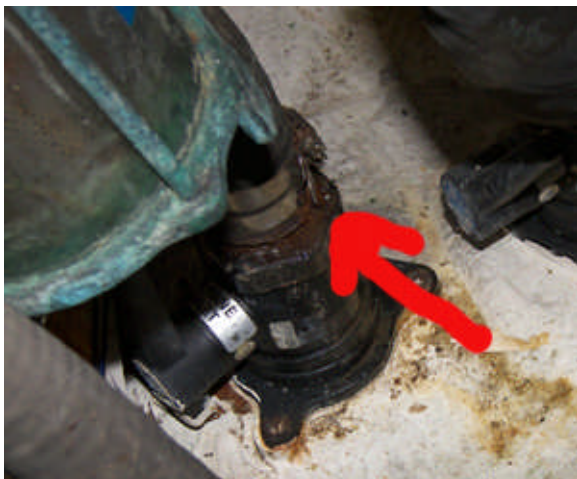
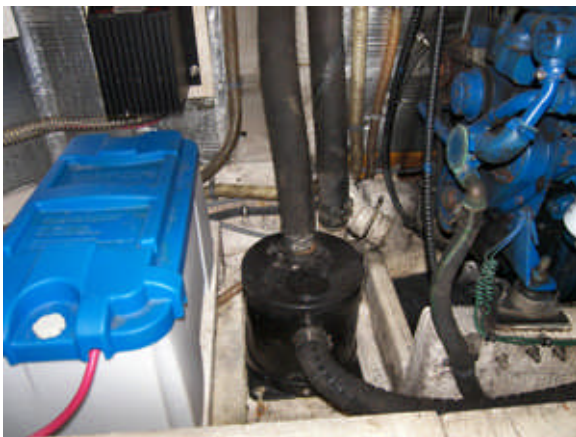
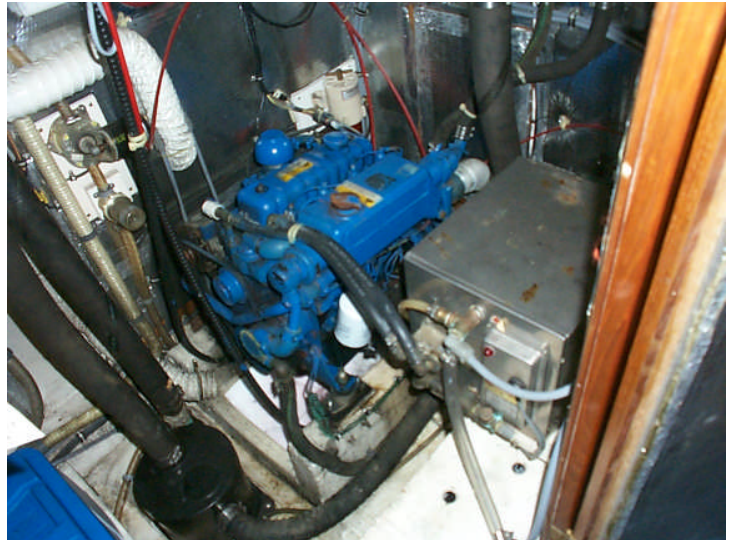
There are two problems in the engine room. (Note photos above left with red arrows) The CNG cylinder rules have changed over the years and these cylinders are no longer permitted in the engine compartment. All rusted hose clamps should be replaced.

Recommendations: Replace rusted hose clamps, remove CNG cylinder from engine room, replace any ferrous fittings on control cables. Note photos on previous pages with red arrows.

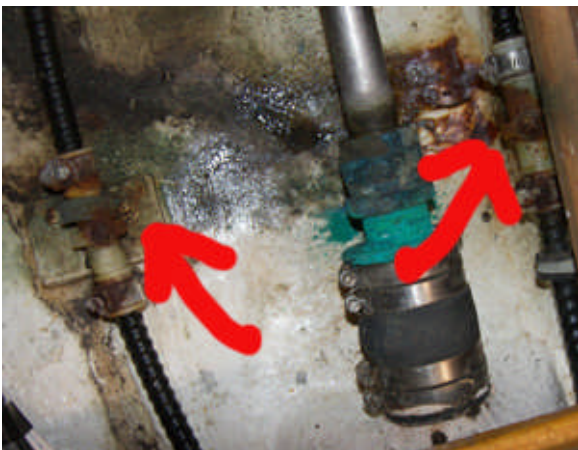
The steel fittings which secure the control cables at left should be replaced with non ferrous fittings.

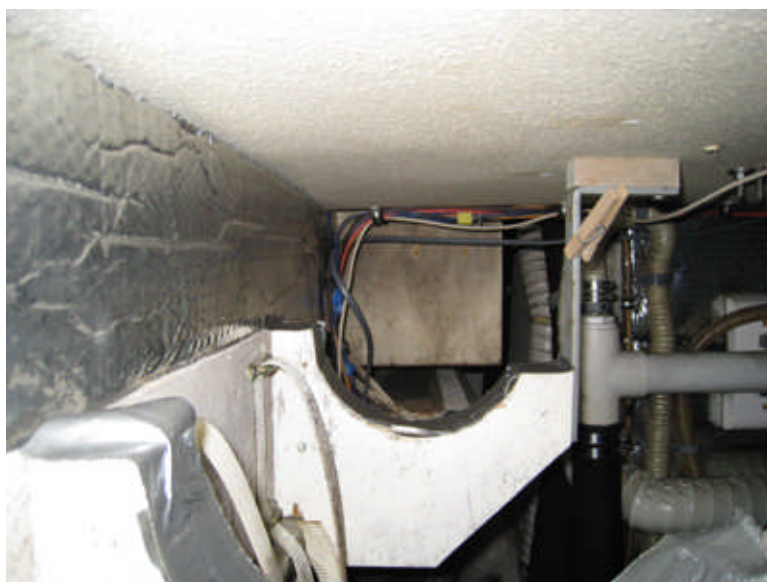
Note the photo at right and compare it to the photo on page seven of your original report.

The cylinder has been removed.
