JAMES CROSS, Certified Marine Surveyor

Re: 2002 Seaswirl 2601 STRIPER

This letter reports the results of a survey of the above vessel which was inspected on August 21st, 2008 while hauled and during a sea trial at Standish Marina in Tiverton, Rhode Island. You requested the inspection to establish its condition and value.

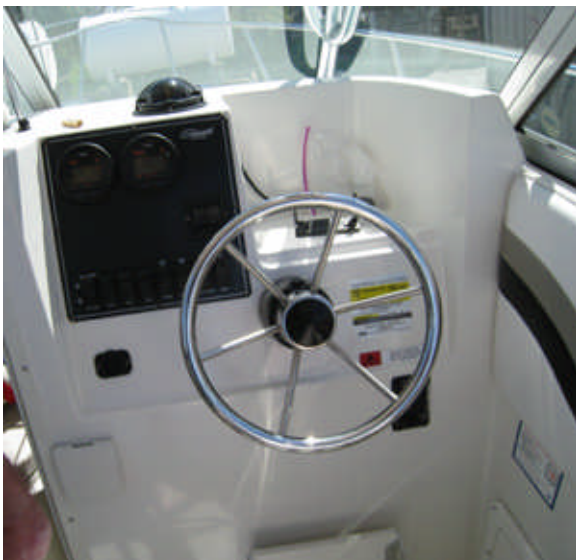
The windshield and supporting structures are in good shape. The steering apparatus is in good condition. All of the rails and cleats are properly secured and constructed of stainless steel. The navigation lights conform to the CFR. The green light at the bow has a crack in the lens.

Recommendations: Insure that a complete up to date Coast Guard Safety and Signalling package is aboard. Install backup ground tackle. Double clamp all through hull fittings below the waterline. Repair leaking trim plane cylinder. Replace cracked navigation light lens.
