JAMES CROSS, Certified Marine Surveyor

March 24, 2008

Re: 2002 Legacy 28 Express

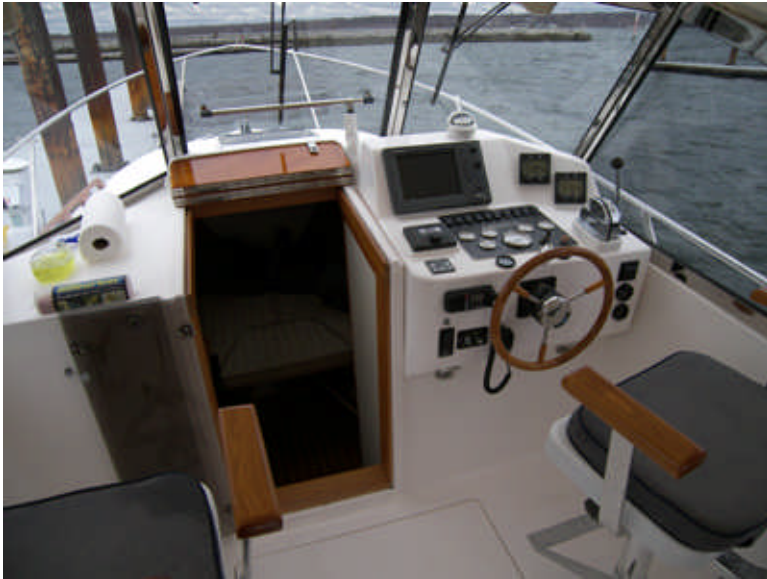
Cockpit, and Operating Station

The station unit is properly attached to the main structure. The weather enclosure and related supports are in good, secure condition. All hatches and ports are in good condition and tight to the weather.

The operating station is well designed and the controls are easy to operate. The upholstery is in very good condition overall. The compass is accurate on its present heading. The shifts and steering are

also smooth operating and in good condition. Steering is hydraulic and the related lines are in good condition. The splash shield is in good, secure condition. All gelcoat surfaces at the operating station appear very lightly used. Overall, the station, including the upholstery is in good condition.

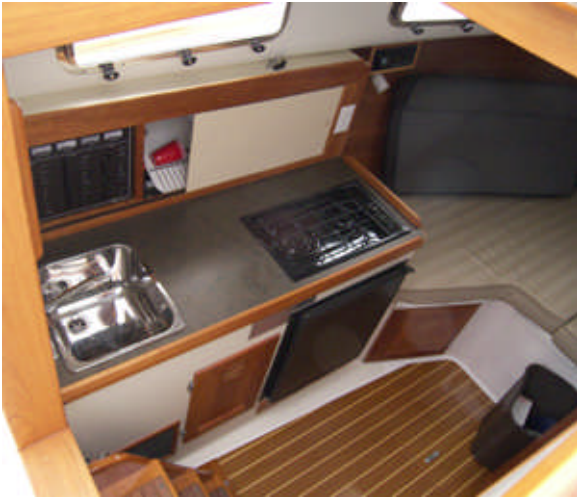
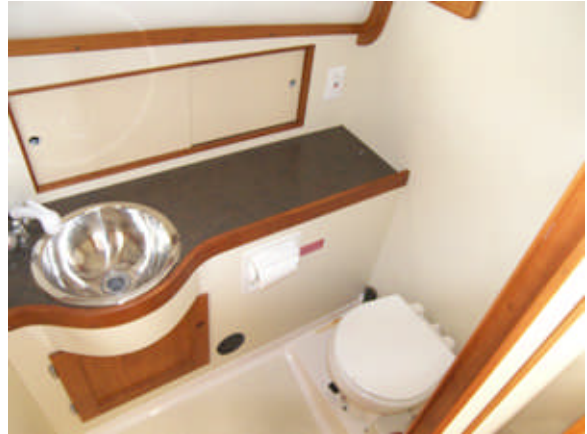
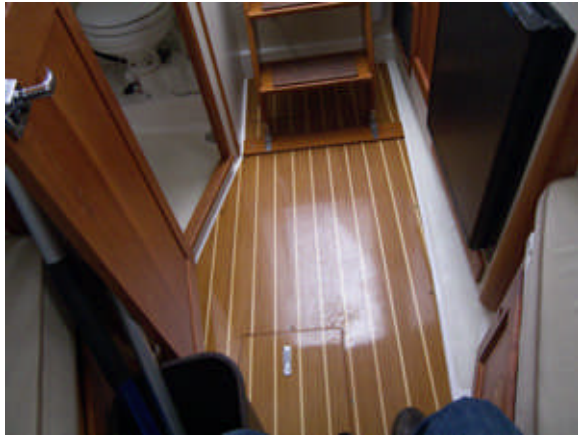
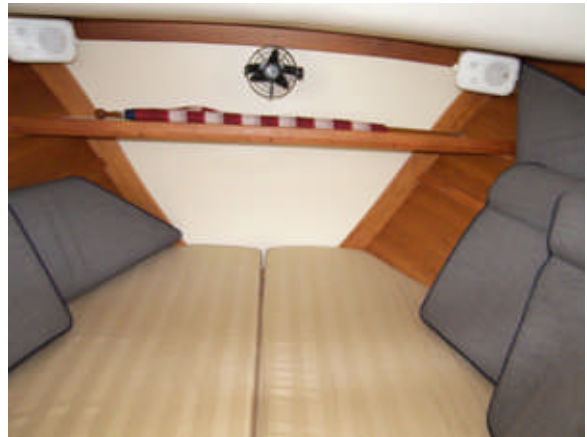
Main Cabin, Galley, and Berth Area

The main cabin is shared by the berth area, the head and galley. This area is spacious, nicely finished and in excellent condition.

The AC/DC refrigerator, AC/Heat system were not checked out while operating, but the components appear in very good condition. (No AC power was available) The combination cooking stove was not checked out. The countertop in the galley is in good shape. There is a stainless steel sink located near the stove and refrigerator in the galley area. The sink and its related faucets and overboard drain are in good condition and clean. The cabinets and all jointer work is in excellent condition. The sole is Teak and Holly, and is in very good condition and feels solid. The vinyl headliner and hull liner appear in good clean condition, free from the usual fresh water stains. The overhead hatch is secure and tight to the weather. The AM-FM Stereo radio with tape deck and appropriate speakers is installed in this area. The upholstered sections in this area are in good shape. Lighting is good throughout the vessel.
