JAMES CROSS, Certified Marine Surveyor

Re: 2002 Seaswirl 2601 STRIPER

This letter reports the results of a survey of the above vessel which was inspected on August 21st, 2008 while hauled and during a sea trial at Standish Marina in Tiverton, Rhode Island. You requested the inspection to establish its condition and value.

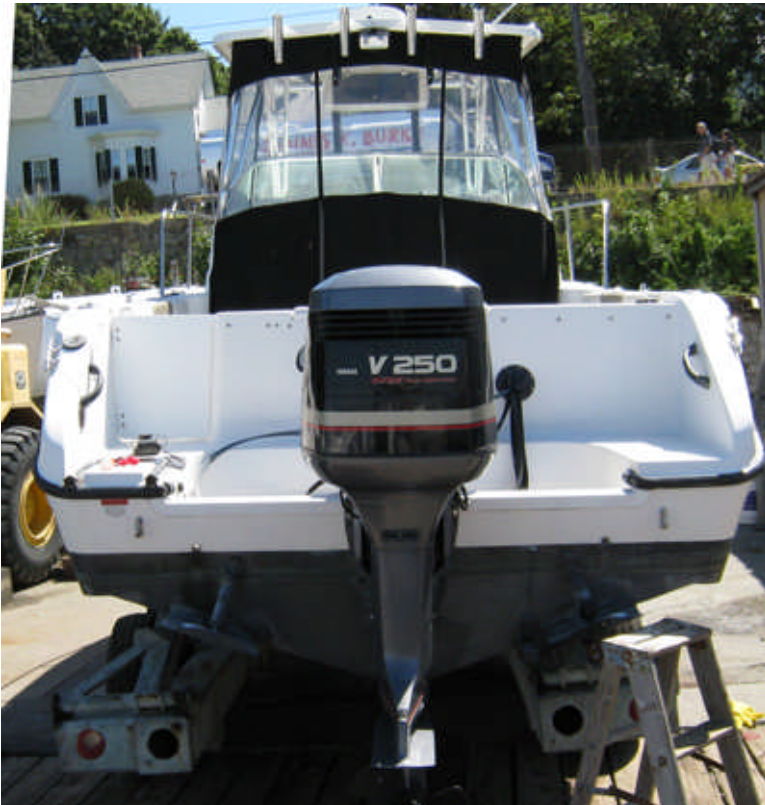
The vessel was built by Seaswirl Boats Inc. of Culver, Oregon in 2002. Moulded into the hull at the transom is the hull ID number (GSSKA028J102. The LOA is 26', and the beam is 8' 6". The draft is approximately 2' 8" and the displacement, according to the book, is 5,300 pounds.
